AC NO: 20-78

MAINTENANCE INSPECTION NOTES FOR McDONNELL DOUGLAS DC-8 SERIES AIRCRAFT

SUBJECT: MAINTENANCE INSPECTION NOTES FOR McDONNELL DOUGLAS DC-8
SERIES AIRCRAFT

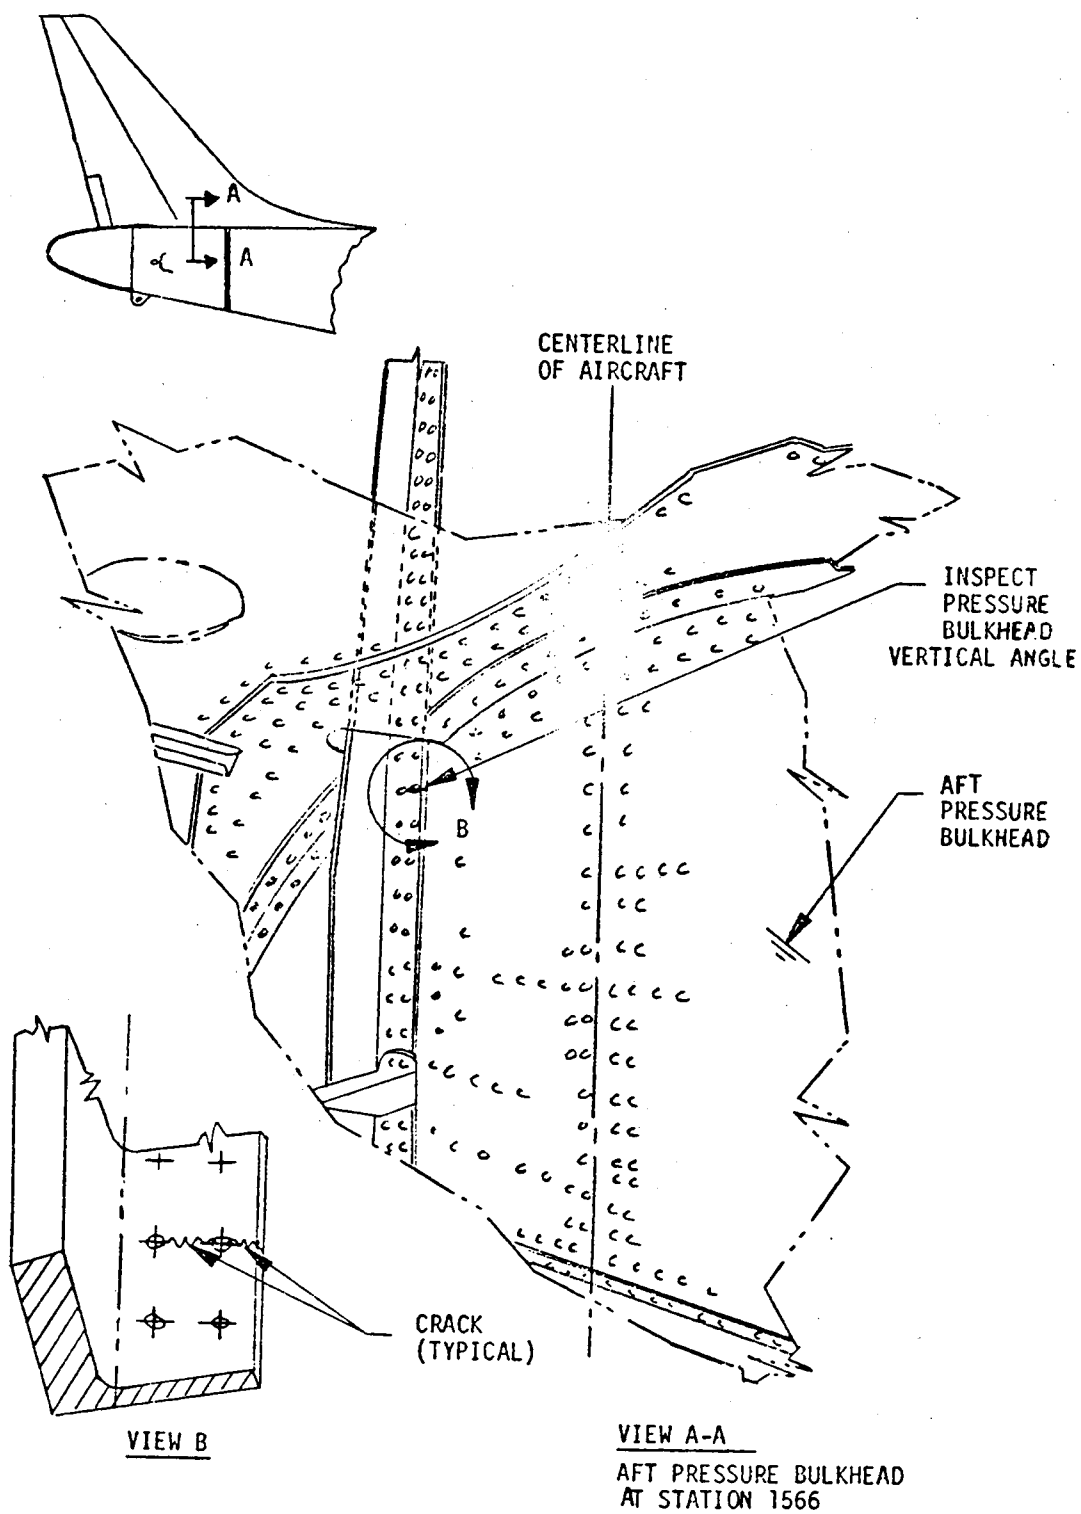
Fig. 8 Fuselage Aft Pressure Bulkhead

- f. Cracks in the domed aft pressure bulkhead have been reported. Cracks were a result of fatigue and occurred at approximately 15,000 flight hours. SB 53-41
10/17/67

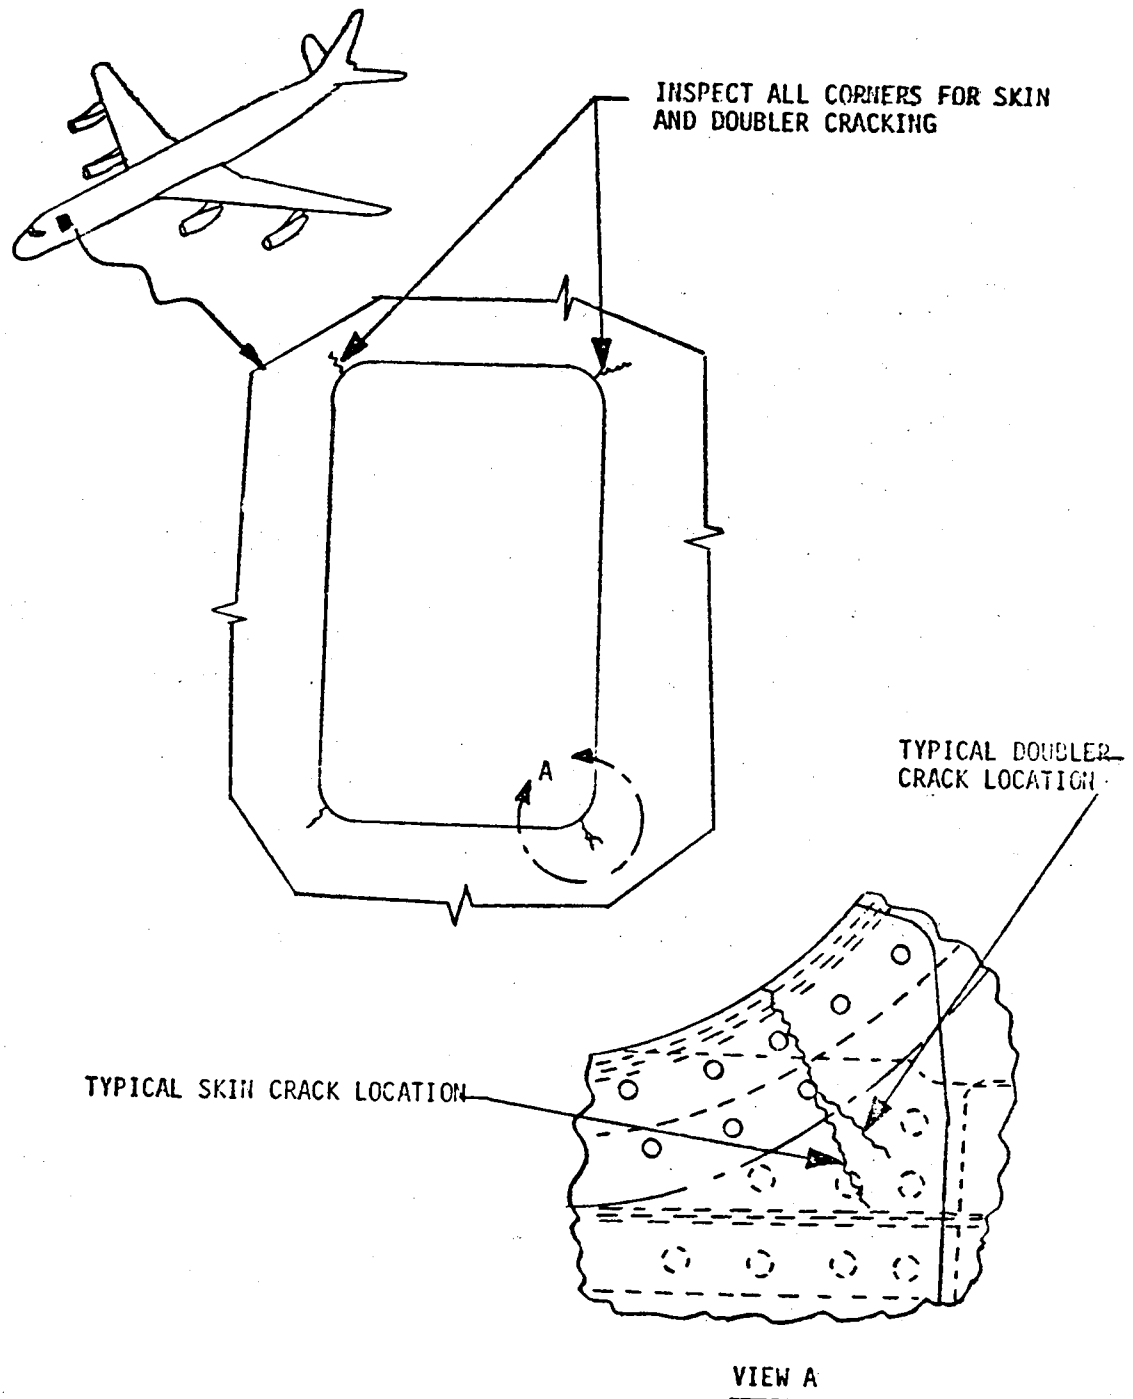
Fig. 10 Forward Passenger Door Areas

- (1) Location. Forward fuselage, left hand side (See Figure 10, Appendix 3).
- (2) Applicable Airworthiness Directive. None.
- (3) Other Reference Data. None

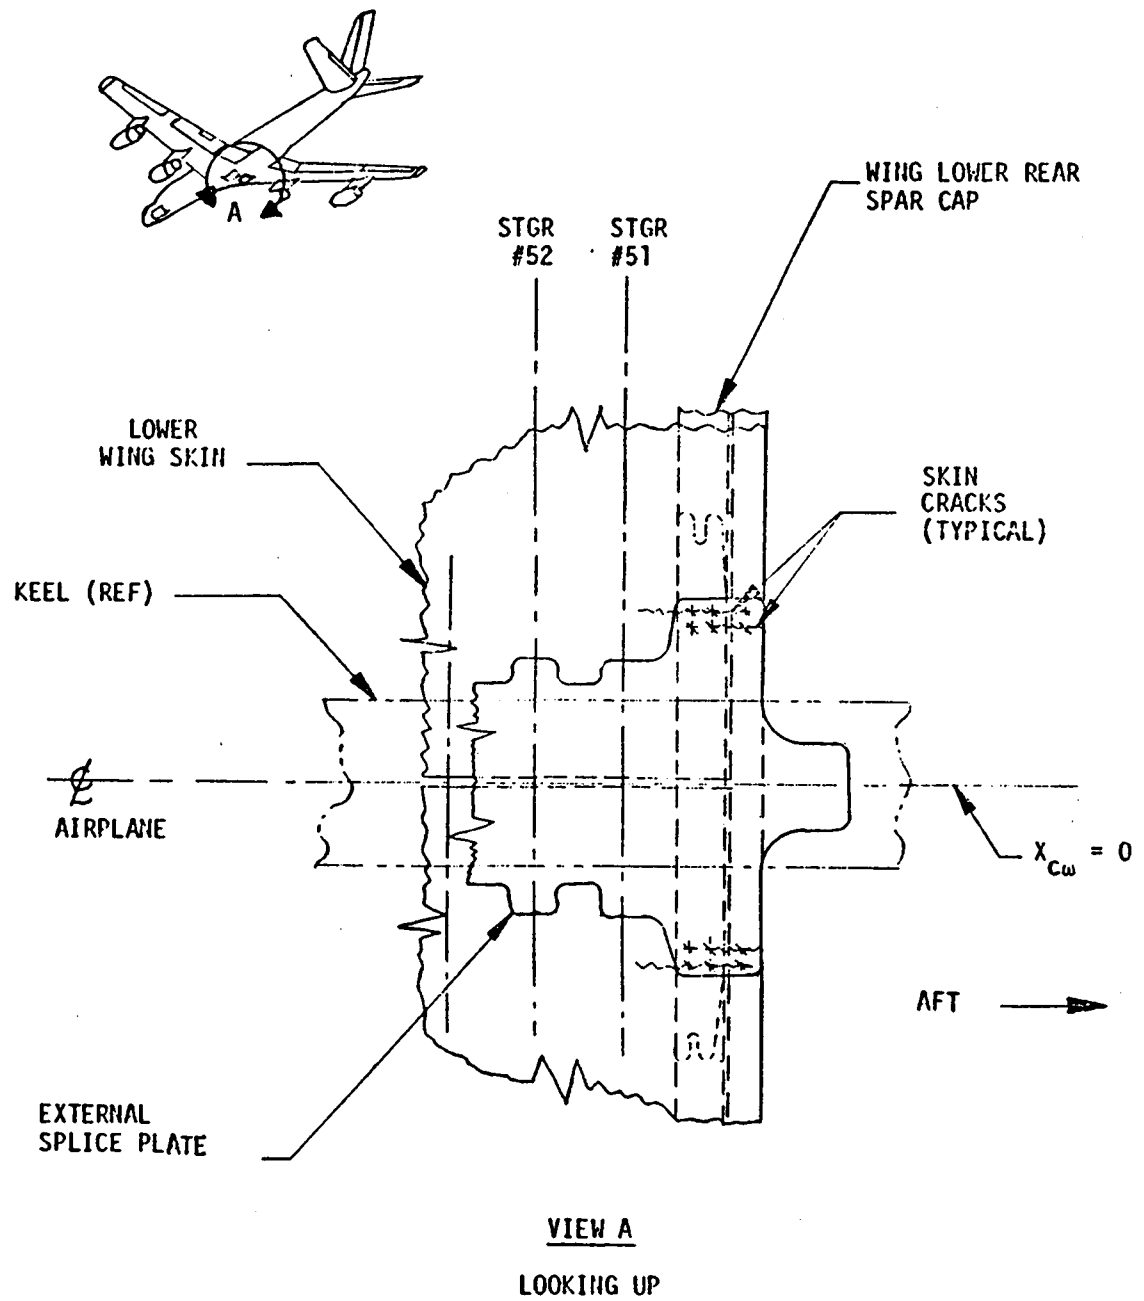
Fig. 12. Aft Lower Skin at Centerline Splice

e. Aft Lower Wing Skin at Centerline Splice.

- (1) Location. Aft lower wing skin at the centerline splice plate attach to the rear spar cap. (See Figure 12, Appendix 3)
- (2) Applicable Airworthiness Directive. None
- (3) Other Reference Documents. None
- (4) Probable Consequences. Crack extension in other area can significantly reduce the structural integrity of the wing.
- (5) Recommendation.
 - (a) Periodically inspect to assure continued structural integrity.
 - (b) Perform preventive rework in this area equivalent to Service Bulletin 57-70 at an appropriate later date depending on the airplane model.
